Citation: Zhou, H., Zhang, Y., Fu, F. & Wu, J. (2020). Collapse Mechanism of Single-Layer Cylindrical Latticed Shell under Severe Earthquake. *Materials*, 13(11), 2519. doi: 10.3390/ma13112519

Collapse Mechanism of Single-Layer Cylindrical Latticed Shell under Severe Earthquake

Abstract: In this paper, the results of finite element analyses of a single-layer cylindrical latticed shell under severe earthquake are presented. A 3D Finite Element model using fiber beam elements is used to investigate the collapse mechanism of this type of shell. The failure criteria of structural members are simulated based on the theory of damage accumulation. Severe earthquakes with peak ground acceleration (PGA) values of 0.5 g are applied to the shell. The stress and deformation of the shell are studied in detail. A three-stage collapse mechanism “double-diagonal -members-failure-belt” of this type of structure is discovered. Based on the analysis results, measures to mitigate the collapse of this type of structure are recommended.

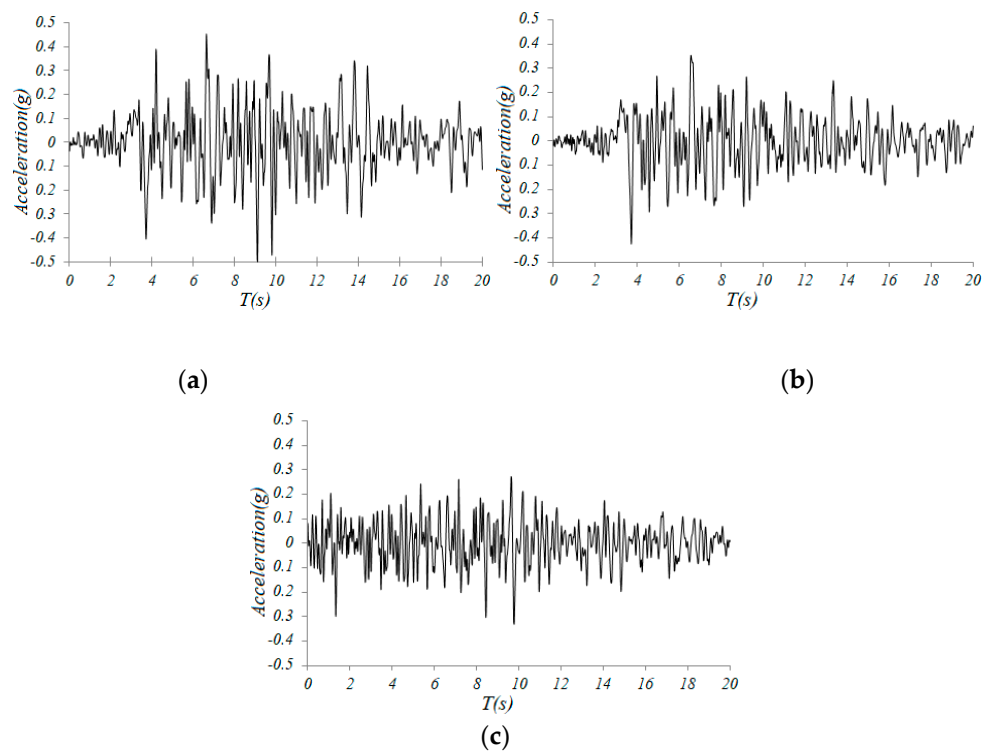
Figure 3. Amplified Taft earthquake wave: (a) X direction, (b) Y direction, (c) Z direction.

The analysis was divided into two steps. The first step was static analysis, where the gravity load was applied to the dome. The second step was dynamic analysis, where the time history of the Taft earthquake (Figure 3) was applied at the support, in X, Y, and Z directions, with the peak ground acceleration (PGA) of 0.5 g in the X direction, $0.85 \times 0.5 \text{ g}$ in the Y direction, and $0.65 \times 0.5 \text{ g}$ in the Z direction, respectively. According to the Chinese earthquake design code [37], the scale factors of 3.211304, 2.370329 and 3.161574 were applied to the original time history in three directions, respectively. The time duration was 20 s, which is greater than 10 times the natural period of the dome. The time step was 0.02 s. The constitutive model of the material uses the hybrid hardening model and the modulus considered the cumulative effect of damage to simulate the performance deterioration of the material, which occurred during plastic tension in the hysteresis process under seismic loading.

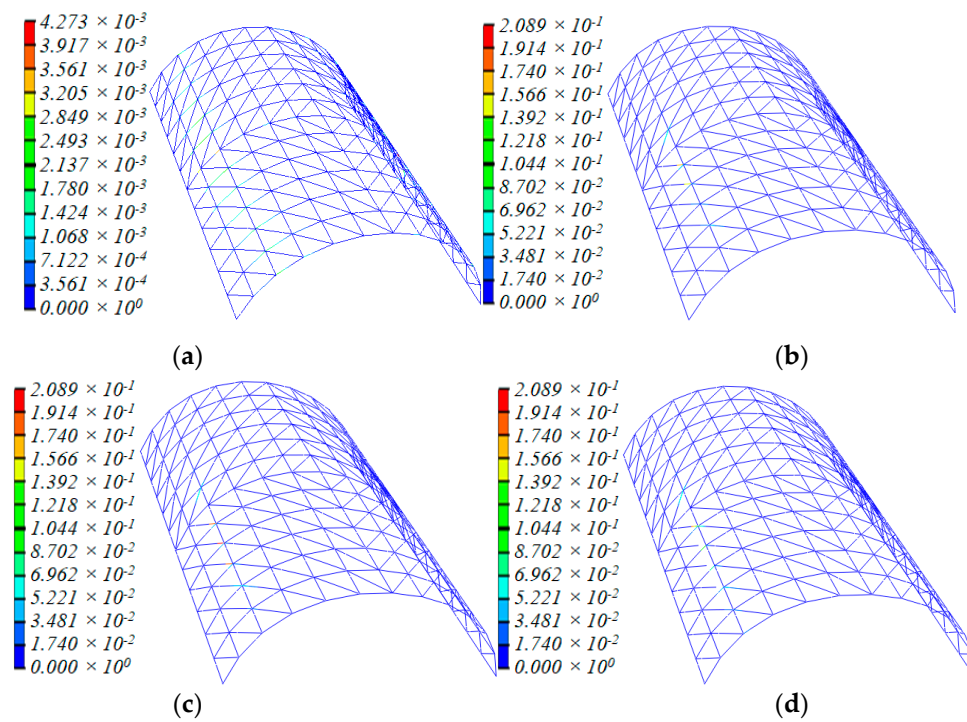
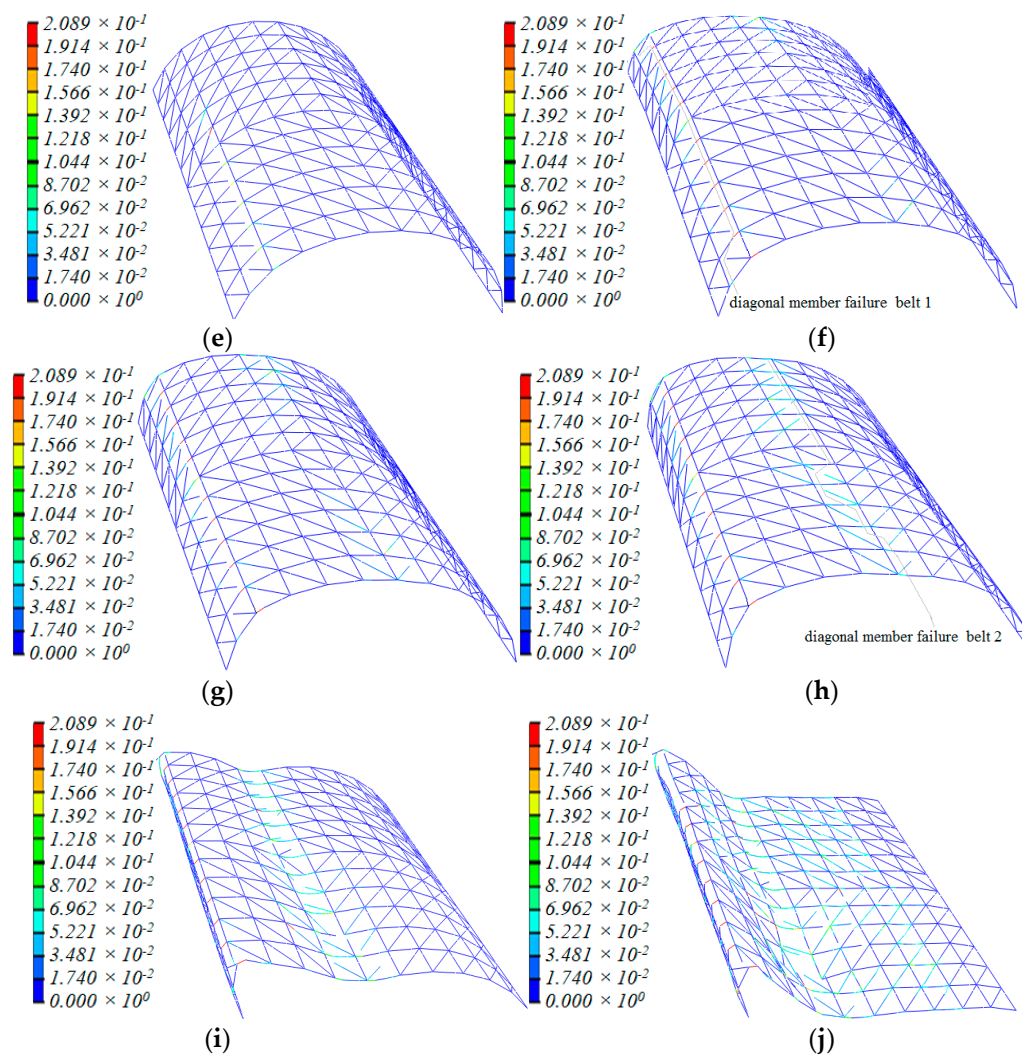
Figure 4. Cont.

Figure 4. Deformation and D value distribution of structural members during the collapse process: (a) $t = 4.56$ s, (b) $t = 6.16$ s, (c) $t = 11.78$ s, (d) $t = 11.80$ s, (e) $t = 12.03$ s, (f) $t = 14.38$ s, (g) $t = 15.40$ s, (h) $t = 15.83$ s, (i) $t = 16.38$ s, (j) $t = 16.78$ s.

Figure 4 depicts the deformation and damage distribution during the collapse process, where the distribution of the D value can be checked. It demonstrates the process where the D value was zero, which indicates that no damage occurred until the rupture of the member when $D > D_{\text{limt}}$.

According to the analysis results, the dome entered the plastic stage at 1.88 s for the first time. Damage distribution spread to zones 2-2 and 3-3 and the symmetric zone of 6-6/7-7, but the D value was extremely small in this stage. With the ground motion continued, at 6.16 s, the D value of many diagonal and lateral members in zones 2-2 and 3-3, at adjacent ends, had obviously exceeded that of members in other zones (Figure 4b). By 11.78 s, the damage state of the whole dome had furtherly deteriorated. The D value of damaged structural members kept rising and more diagonal and lateral members were damaged. At 11.80 s, three diagonal bars in zone 2-2 failed at the ends of the joints with a threshold value of 0.209.

At 12.03 s, all the diagonal members in zone 2-2 failed, while the damage range spread to the left of the zone, with the damage area increased dramatically, although no member failure was observed. At 14.38 s, all the diagonal members in zone 2-2 failed because of continuous damage accumulation, and the failed zone was like a continuous and regular “diagonal member failure belt”. Lateral bars were left unbroken and the damage area continue to propagate. The deflection of the dome had been significant. Furthermore, some lateral members and diagonal members in zone 6-6/7-7 were damaged.

Afterwards, the damage area was found between zones 6-6 and 7-7. At 15.40 s, most diagonal members in the zone were damaged and a few at two longitudinal ends failed. By 15.83 s, most diagonal members in zone 6-6 and two diagonal members at the right of zone 7-7 had failed. The position of structural members failed in a similar manner to the “diagonal member failure belt” with its width becoming slightly wider than when it first came into being (Figure 4h). No lateral members failed, though they were obviously damaged. Furthermore, the overall downward deflection of the dome became significant during this process. With the continuous action of the earthquake, the dome began to collapse downward rapidly. Horizontally, the dome collapsed towards the position of the first “diagonal member failure belt”, the whole dome now looked like an italic letter “M”. Finally, 1.13 s later, with the formation of the second “diagonal member failure belt”, the dome collapsed totally. The D value of longitudinal bars of the dome had not increased much throughout.

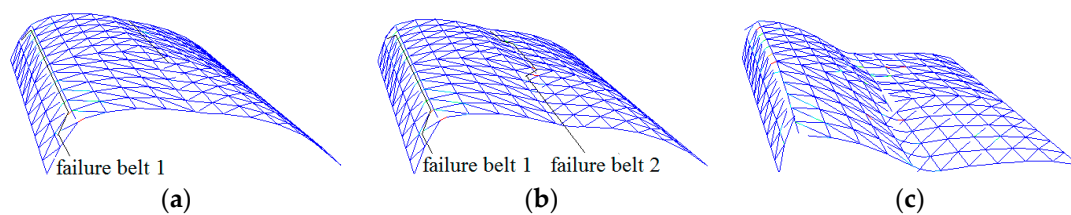
Figure 5. Collapse process of cylindrical reticulated domes of different span/depth ratios at typical times (span/depth = 4:1): (a) belt 1 formed, (b) belt 2 formed, (c) dome collapses.

Figures 5 and 6 depict the deformation and distribution of the damage of the structural member during the collapse process for the other two domes, with span:depth ratios of 4:1 and 2:1, respectively. Their spans are kept at 20 m. Figures 7 and 8, respectively, depict the other two 20-m-span domes, one with a length:width ratio of 1:1, another with a ratio of 2:1. With the increase in the length:width ratio, the position of the “diagonal member failure belt” moved from zones 2-2/6-6 to 3-3/7-7. The decrease in the length:width ratio caused a contrasting trend. With the exception of the above, the basic process of collapse and final collapse forms are similar.

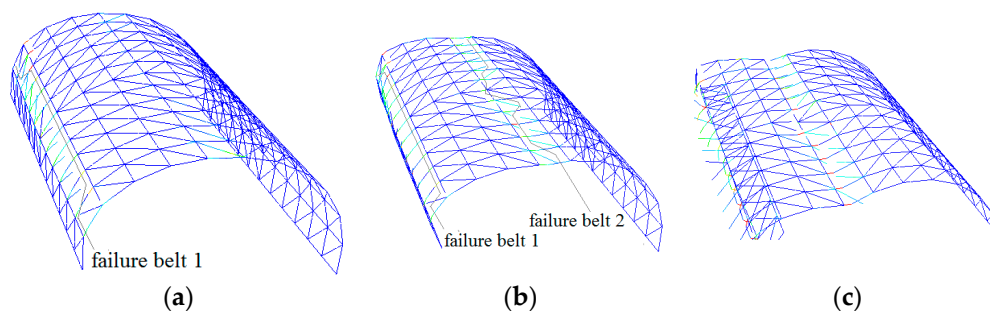
Figure 6. Collapse process of cylindrical reticulated domes of different span/depth ratios at typical times (span/depth = 2:1): (a) belt 1 formed, (b) belt 2 formed, (c) dome collapses.

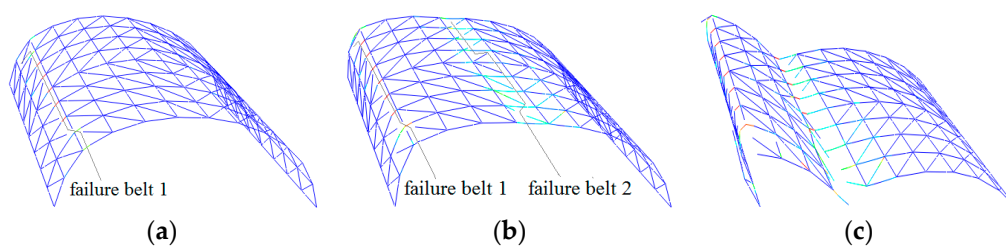
Figure 7. Collapse process of cylindrical reticulated domes of different length/width ratios at typical times (length/width = 1:1): (a) belt 1 formed, (b) belt 2 formed, (c) dome collapses.

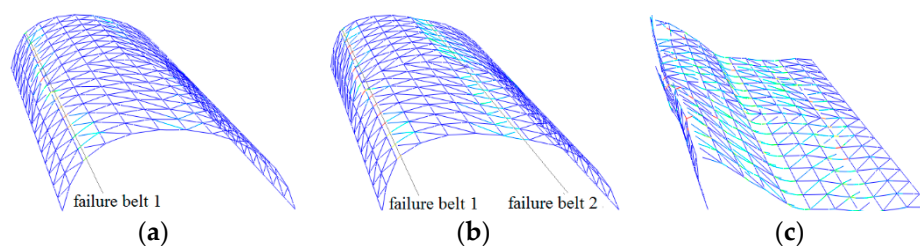
Figure 8. Collapse process of cylindrical reticulated domes of different length/width ratios at typical times (length/width = 2:1): (a) belt 1 formed, (b) belt 2 formed, (c) dome collapses.

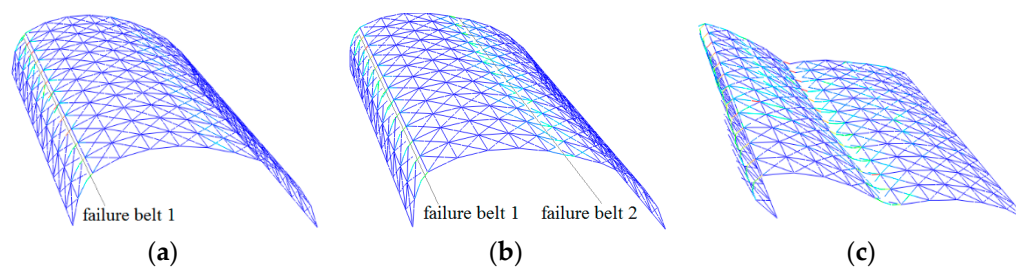
Figure 9. Double diagonal member failure belt: (a) belt 1 formed, (b) belt 2 formed, (c) dome collapses.

Figure 9 depicts the failure mode of double-diagonal member cylindrical reticulated domes, which are similar to single-diagonal member cylindrical reticulated domes.

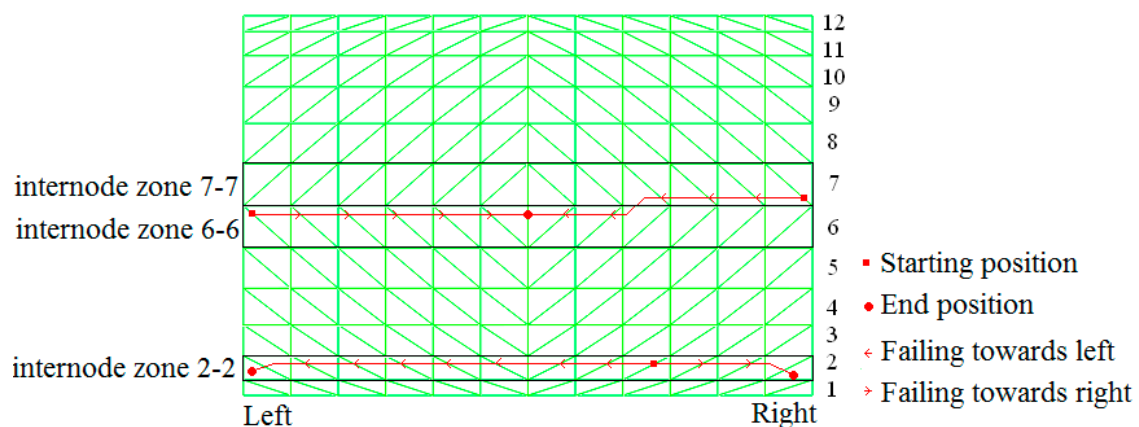
Figure 10. The demonstration of the collapse mechanism of the shell.

Therefore, a consistent failure pattern for the collapse process of single-layer cylindrical reticulated domes can be concluded. Under severe earthquakes, serious damaged first occurs at 1/4 height of the dome. Diagonal members failed continuously from the center to the boundary lengthwise and the first “diagonal member failure belt” came into being (Figure 10). The stiffness of the dome also greatly weakened. Then, another damaged zone appeared at the middle of the dome and, in this zone, diagonal members failed continuously lengthwise from the ends to the center. A second “diagonal member failure belt” was formed. The stiffness of the dome was reduced further. The whole deflection became significant. The position of the “belt” varied slightly with the change in geometry. In the final stage, the dome deflected rapidly at the second “belt”, dropping towards the first “belt”. The dome collapsed. We call this collapse process and phenomenon the “double-diagonal -members-failure-belt” pattern.

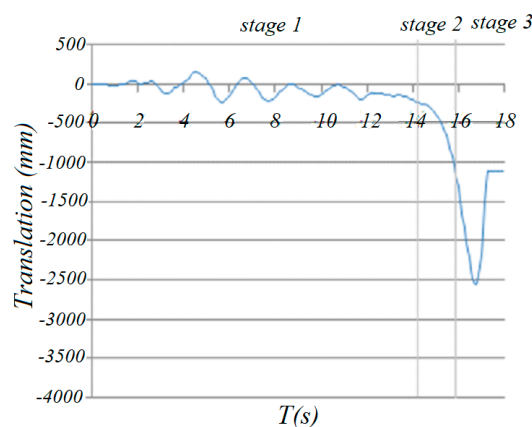
Figure 11. The horizontal translation of gravity center in X direction.

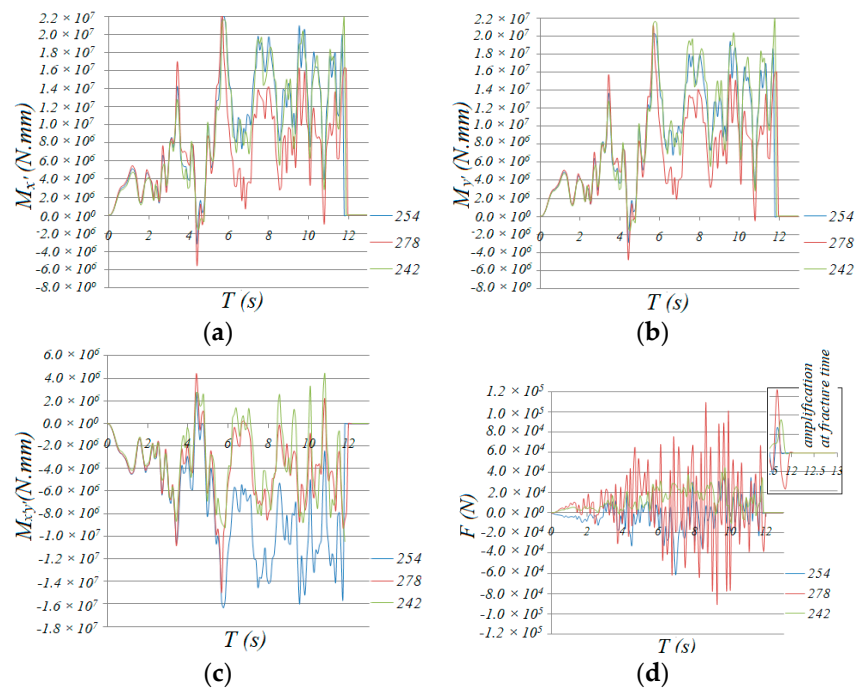
Figure 12. Time history of the internal force of the diagonal members: (a) $M_{x'}$, (b) $M_{y'}$, (c) $M_{xy'}$, (d) F .

As shown in Figure 12, through a comparison of the time history curves of bending moments $M_{x'}$ and $M_{y'}$, torsion $M_{x'y'}$ and axial force F of members 242/254/278 in zone 2-2, it can be found that, although the axial force F of 254 was less than that of 242, the bending moments $M_{x'}$ and $M_{y'}$ and torsion $M_{x'y'}$ of 254 are obviously larger than those of 242. The axial force and bending moments of 278 are approximate to those of 254, but the torsion of 278 is less than that of 242. So, the D values of the slant bar of 254 and neighboring bars in zone 2-2 are obviously larger than those of other bars (Figure 4b,c).

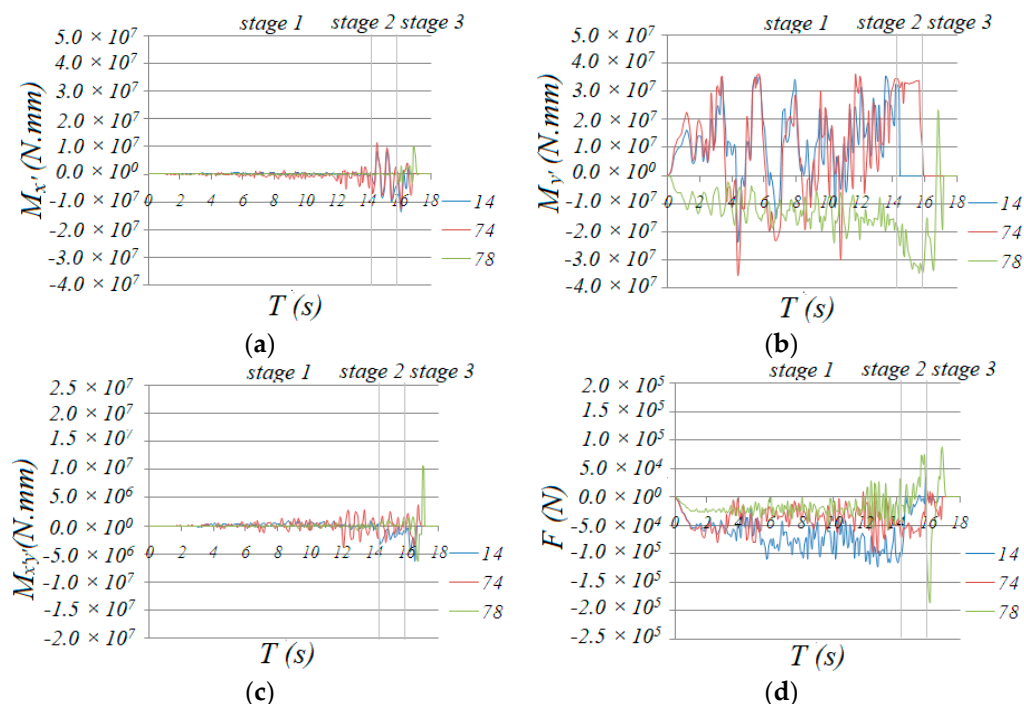
Figure 13. Time history of internal forces of traverse bar 14, 78 and 74: (a) $M_{x'}$, (b) $M_{y'}$, (c) $M_{xy'}$, (d) F .

According to Figure 13, which shows the variety of internal forces of traverse bars 14, 78 and 74 at the center of zone 2-2, the traverse bars are mainly subjected to bending moment $M_{y'}$, while axial force F , bending moment $M_{x'}$ and torsion $M_{x'y'}$ at this stage are minimal, so $M_{y'}$ contributed mainly to the damage increment. This is why, in Figure 14, the normal stresses of upper section fiber 3 and lower section fiber 7 were much larger than those of middle section fibers 1 and 5, which hardly exceeded the yield point and caused corresponding material damage. Thus, damage development concentrated in fiber 3 and 7 and traverse bars hardly failed. This is the common response observed in all the transverse bars of the monoclinic and double-skew cylindrical reticulated domes under the same ground motion.

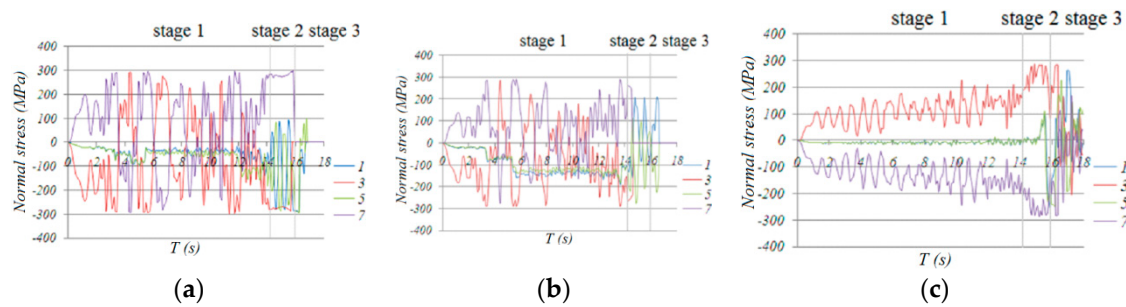
Figure 14. Time history of normal stress in fiber 1,3,5,7 of traverse bar 14, 78 and 74: (a) bar 74, (b) bar 14, (c) bar 78.

In Figure 14a, we can see that the normal stress at upper fiber 3 and lower fiber 7 at the end section of traverse bar 74 was maintained at a value of 280 MPa, which was much greater than the initial yield stress of 235 MPa, while the normal stress of fibers 5 and 1 also increased dramatically, acting as a plastic hinge. Fiber 3 and 7 of traverse bar 14 failed at a short time after entering this stage, but the stress of fibers 1 and 5, whose stress was relatively small, increased rapidly to around 200 MPa. We can conclude that the normal stresses of the remaining fibers of bar 14 were larger than the yield point. This means that the end of bar 14 acted as a plastic hinge as well. Finally, we can conclude that all the traverse bars in zone 2-2 that had not yet failed acted as plastic hinges. The formation of plastic hinges induced significant internal force redistribution effect. As shown in Figure 17, the bending moment M_y , axial force F , bending moment $M_{x'}$ and torsion $M_{x'y'}$ of diagonal bars 161 and 232 (Figure 1), one at the end and the other at the mid of zone 6-6, were less than those of bars 242, 254 or 278 (Figure 12) in stage 1. Thus, almost no damage was done to these bars. However, the value of M_y , $M_{x'}$, torsion $M_{x'y'}$, began rapid increasing since the formation of the first “belt”.

The successive failure of diagonal members and damage to traverse bars in zone 6-6 greatly weakened the vertical stiffness of the dome. Thus, under the earthquake loading, the dome deflected downwards significantly. At the same time, angular displacement was observed in the traverse bars in zone 2-2, which made damage in fibers 3 and 7 develop rapidly (Figure 14).

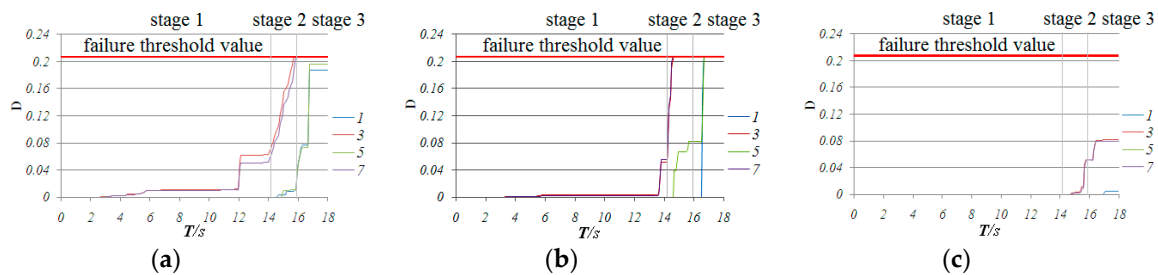
Figure 15. Time history of D value in fiber 1,3,5,7 of bar 14, 78 and 74: (a) bar 74, (b) bar 14, (c) bar 78.

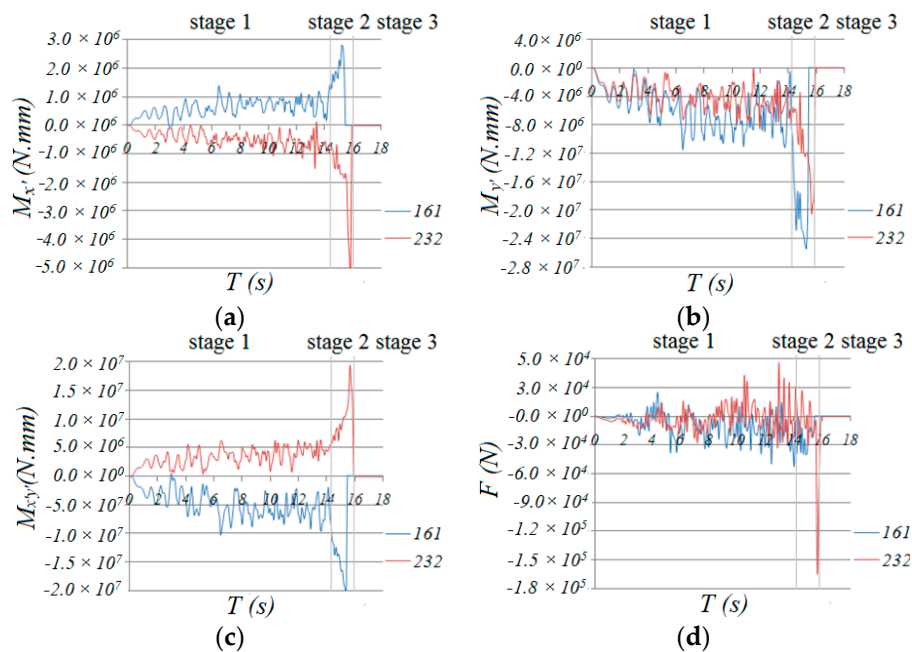
Figure 17. Time history of internal forces of diagonal bar 161 and 232: (a) M_x , (b) M_y , (c) M_{xy} , (d) F .

Therefore, continuously increasing the internal force induced by ground motion resulted in severe damage to the diagonal bars 0.8 s later when entering the second stage, because the internal forces of the bars at two ends were larger than that of the bars in the middle; the bars at the ends of the nodes of zone 6-6 failed first (Figure 4g). Then, the other bars failed successively from both ends to the middle in a short time. Finally, at 15.83 s, the second belt was formed.

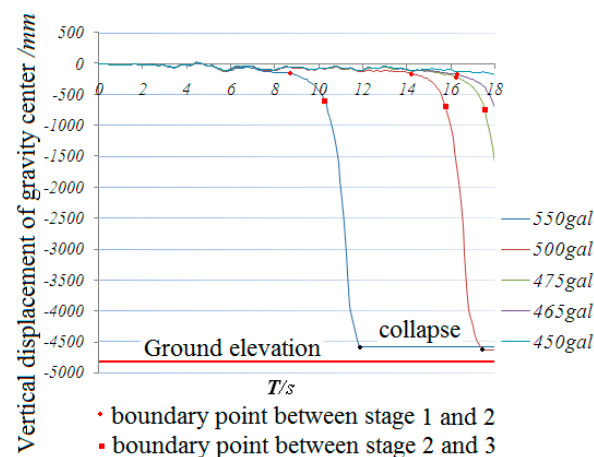
Figure 20. Time history of vertical translation of gravity center.

The deformation of the dome changed throughout the whole collapse process; therefore, the center of the structure changed as well. Figure 20 shows the change in the locations of the center of gravity of the structure during the whole collapse process. Different peak ground acceleration values were selected with the same duration of 18 s. It can be seen that the center of gravity decreased with the different PGA values.

When PGA was 0.45 g, the damage was observed at 1.9 s and the rupture of the first diagonal bar occurred at 16.44 s. However, the failure belt was not formed until 18 s. At 1.9 s, the location of the center of the gravity fluctuated and no significant acceleration in the center of gravity was observed.

When PGA was 0.465 g, the first diagonal member failure belt formed at 16.55 s. The second belt started to form at 17.63 s. However, the failure belt was not formed until 18 s. It can also be observed that the slope of the curve in Figure 17 increased dramatically.

When PGA was 0.475 g, the rupture of the first diagonal member failure belt formed at 16.38 s. The second belt started to form at 17.48 s. However, it can also be observed that the slope of the curve increased at stage 2 compared to stage 3. When PGA was 0.5 g, the rupture of the first diagonal member failure belt occurred at 14.38 s. The second belt started to form at 15.83 s.

It can also be seen that when PGA was 0.475 g, the acceleration distance of the center reached 1286mm; however, for a larger PGA of 0.5 g, when the time was shorter than 16 s, the acceleration distance of the center was smaller than 1286 mm, which indicates the effect of the duration on the time history.

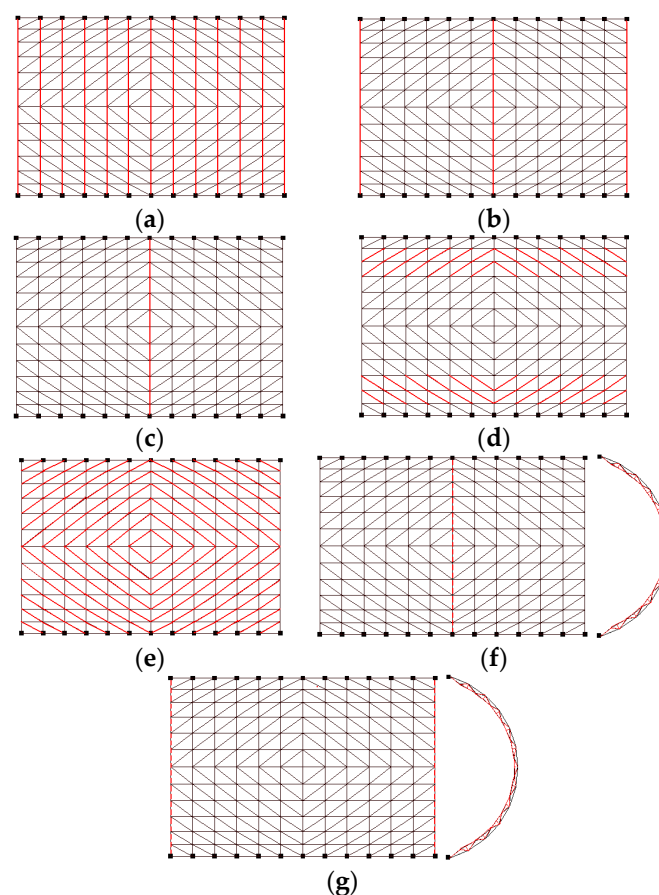
Figure 21. Seven different schemes to enhance the dome: (a) scheme 1, (b)scheme 2, (c) scheme 4, (d) scheme 4, (e) scheme 5, (f) scheme 6, (g) scheme 7.

Note: Red solid line represents the enhanced bars; the red dotted line indicates the plane arch truss. The height of the truss section is 450mm, and the diameter of the truss web members is $\Phi 30 \times 3.5$

Based on the numerical simulation results, seven mitigation schemes were developed to prevent the collapse of the dome: in Figure 21a, the cross section of all top chords in the transverse direction increased. In Figure 21b, the cross section of three top chords in the transverse direction increased. In Figure 21c, the cross section of the top chords at center was increased. In Figure 21d, the cross section of the diagonal members as shown in the Figure increased. In Figure 21e, the cross section of all the diagonal members increased. In Figure 21f, extra diagonal and bottom cords were added to the arch at the center of the shell. In Figure 21g, extra diagonal and bottom cords were added to the two arches at the end of the shell. All the increased section sizes used the ones specified in GBT17395-1998 [38], with a wall thickness of 6 mm.

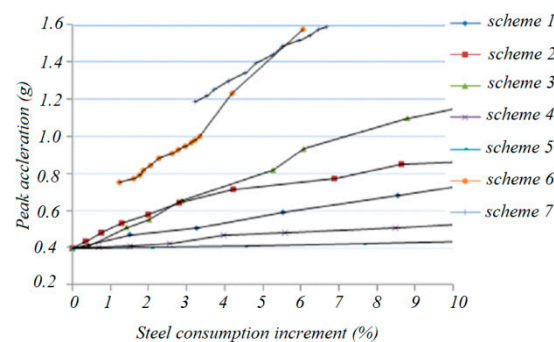
Figure 22. Relation between collapse peak acceleration vs. steel consumption increment.

A time history analysis was performed for all seven enhanced schemes. The results are shown in Figures 22 and 23. Figure 22 shows the relationship between the various earthquake inputs with the increase in the use of the steel material.

It can be seen that, with the increase in the steel consumption, the collapse peak acceleration, which can be taken as the seismic capacity index of schemes 6 and 7, increases most rapidly. On the other hand, for schemes 2 and 3, the capacity index increases less than in schemes 6 and 7, while in schemes 4 and 5, the capacity index increases the least.

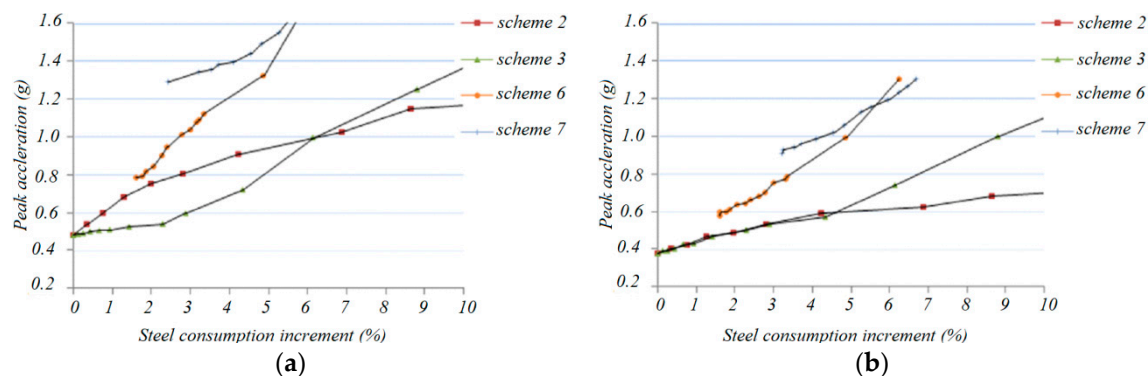
Figure 23. Curve of acceleration vs. steel consumption increment under various live loads: (a) proof live load 1.3 KN/m^2 , (b) proof live load 1.7 KN/m^2 .

Figure 23 shows the relationship between the various live loads (1.3 KN/m^2 and 1.7 KN/m^2) on the roof with the use of the steel material after the analysis. It can be seen that scheme 7 shows a reasonably high earthquake resistance with a small increase in steel usage.
